WHITE PAPER

Horizon straightening

January 2023

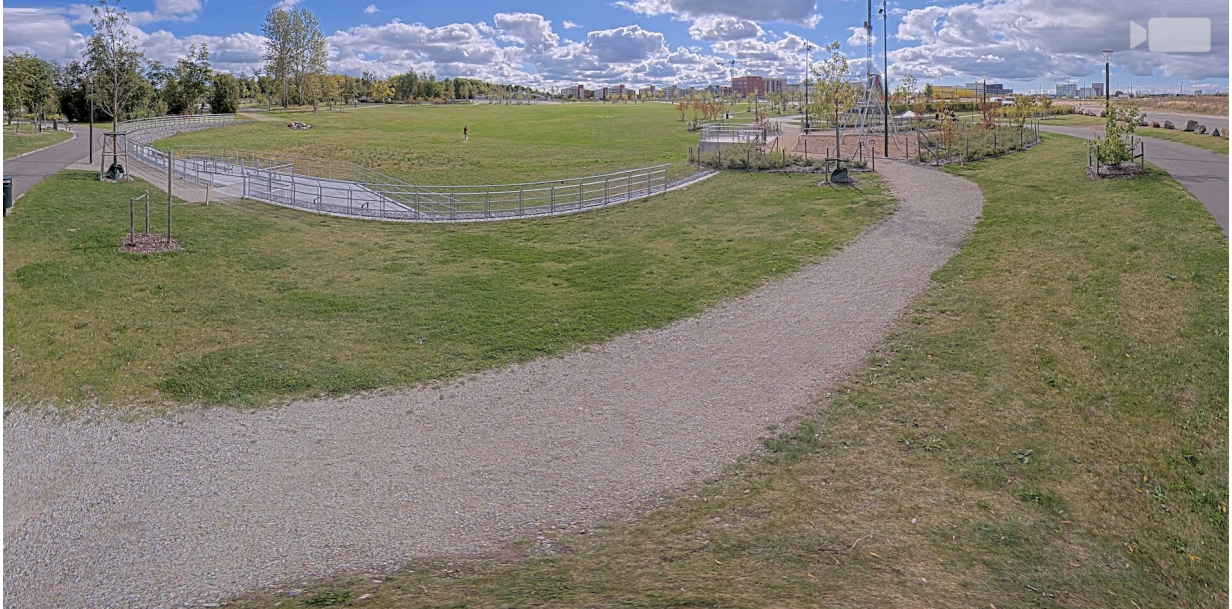
180-degree view captured with a panoramic camera with horizon straightening. Even though the camera is downtilted, the horizon is straight and objects that are vertical in real life stay vertical in the image.

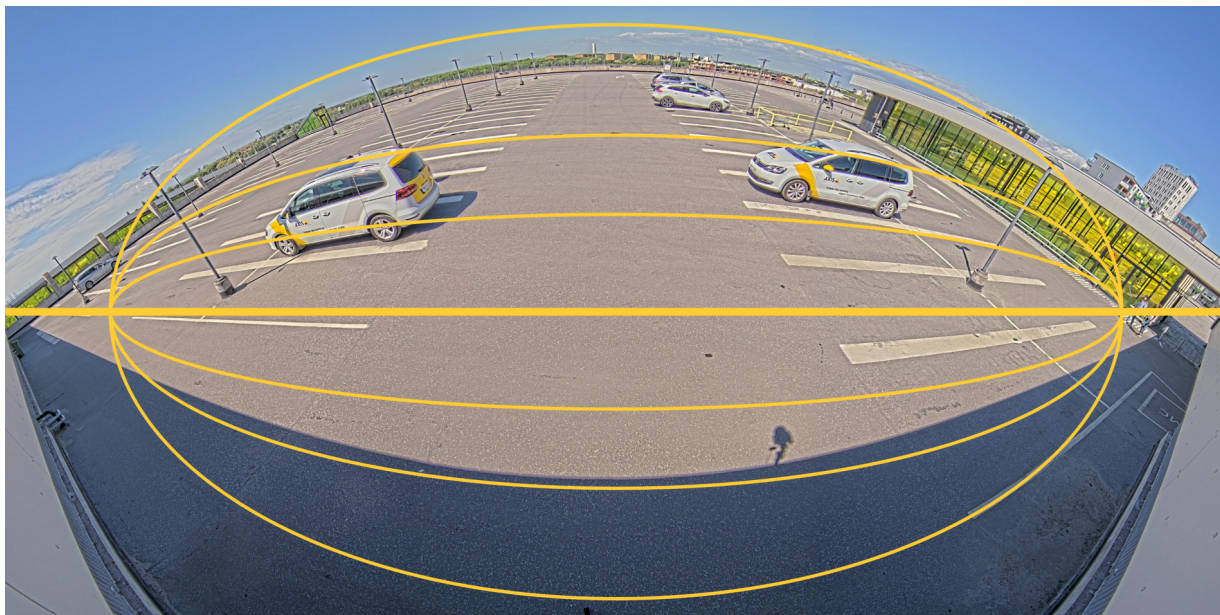
180-degree panoramic view snapshot taken with a multisensor camera without horizon straightening. The lines added on the image give a clue about how the wide-angle multisensor output has been projected to create one, rectangular image. All lines come off as bent or tilted except for the horizontal and vertical center of the view.

The way the image is projected in a panoramic camera requires everything in the view to be bent around a center line. To maximize the use of each image sensor, the image is usually projected so that this line is in the center of the image. If the horizon happens to be located on the center line, it will be straight. But if the camera has been tilted so that the horizon is not in the middle of the image, the horizon will be bent.

The above panoramic image is fully functional but the viewing experience could be further improved. The fact that the image content is not straight may also affect the results of object detection analytics, if any such video analytics are applied.

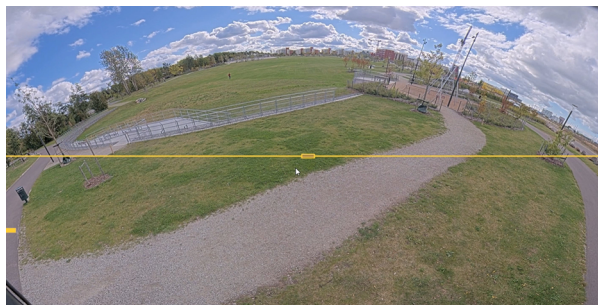
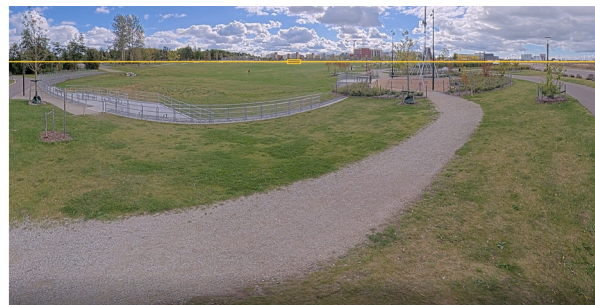
180-degree panoramic view snapshots taken with a multisensor camera.

Left: Without horizon straightening, the image is bent around the camera view's center line (marked in yellow). Due to camera downtilt, this line is not at the horizon.

Right: With horizon straightening, the camera downtilt is compensated and the image is projected around the horizon.

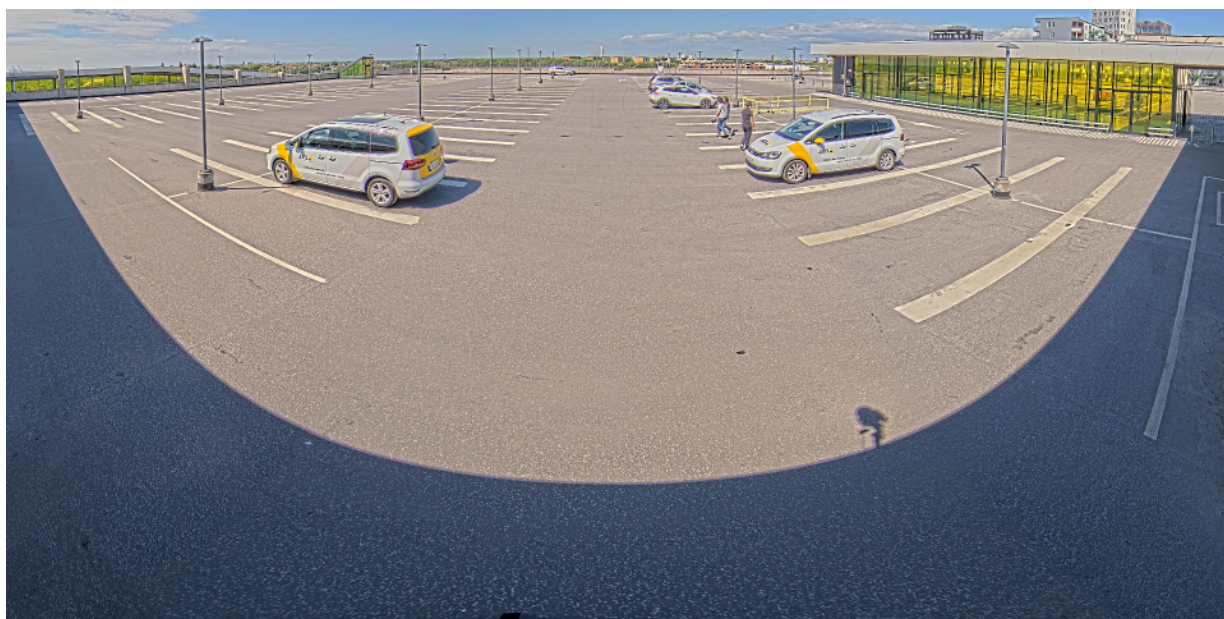
180-degree panoramic view snapshot taken with a multisensor camera with horizon straightening. The horizon is straight and vertical objects are vertical.

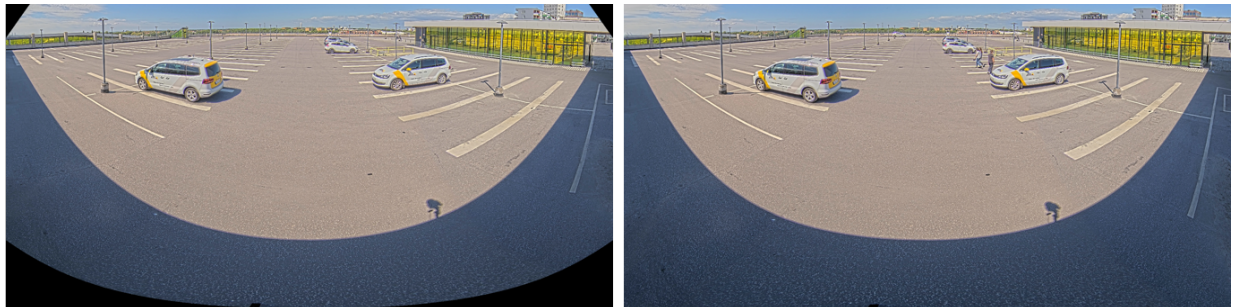
The areas in the corners of the image where there is no information from the image sensors can be preserved (displayed as black pixels) (left) or stretched (right) according to user preference.

The straightened image will lack sensor information in its corners. This is because the camera's coverage is not enough to fill all the pixels of the non-rectangular image. You can choose to preserve the corners as black, possibly combined with cropping the image so the corners are not visible anyway. But *horizon*

straightening also has the ability to create a good visual result by gently and smartly stretching the available data to fill in the corners and provide a complete picture without black corners. Maximum coverage is kept along the horizon both in a stretched image and in an image with preserved, black corners.

The stretching works differently depending on what amount of stretching you choose. Set to maximum, stretching takes place mainly in the bottom part of the image and may have a large effect on the appearance of objects that are located there. Set to minimum, stretching affects a larger part of the image, but with smaller effects throughout. Minimum stretch will also keep the noise level down, which may be especially important in low light scenes.
