# Tested without compromise

Ensuring quality in Axis cameras

January 2018

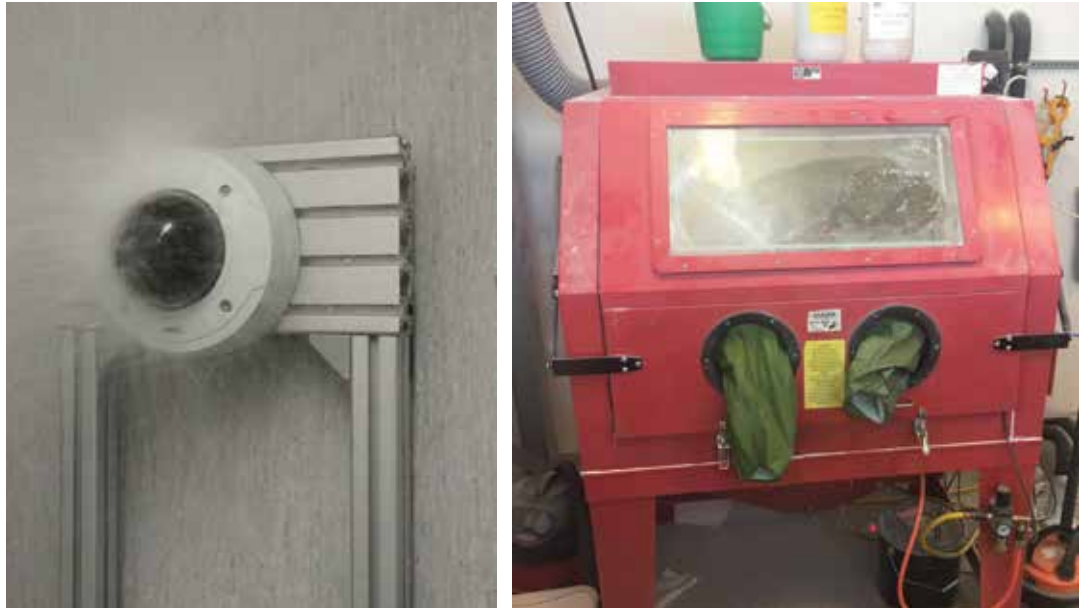
Figure 3: Left: Water-proof test of a camera, right: Dust lab.

For IP66, the IP class of most Axis outdoor cameras, the procedure consists of two tests. During the first one, the camera is placed in a dust chamber and subjected to extremely high levels of fine grain talc, at an underpressure of 20 mbar (15 mmHg, 0.29 psi), for a period of 2 hours. The dust level is high enough to present a severe health risk to anyone exposed to it for a prolonged period of time. It is a good indicator of the housing integrity of a camera and the quality of its sealing gaskets.

During the next test, the camera is exposed to a high pressure water stream with a flow rate of 100l/ minute (26 gallons/minute) onto the camera from 2.5-3 m (8ft 2 in-9ft 10in) away. Following the test, the camera is opened and inspected for water ingress with special attention paid to its sealing gaskets. Its functionality is also thoroughly checked.

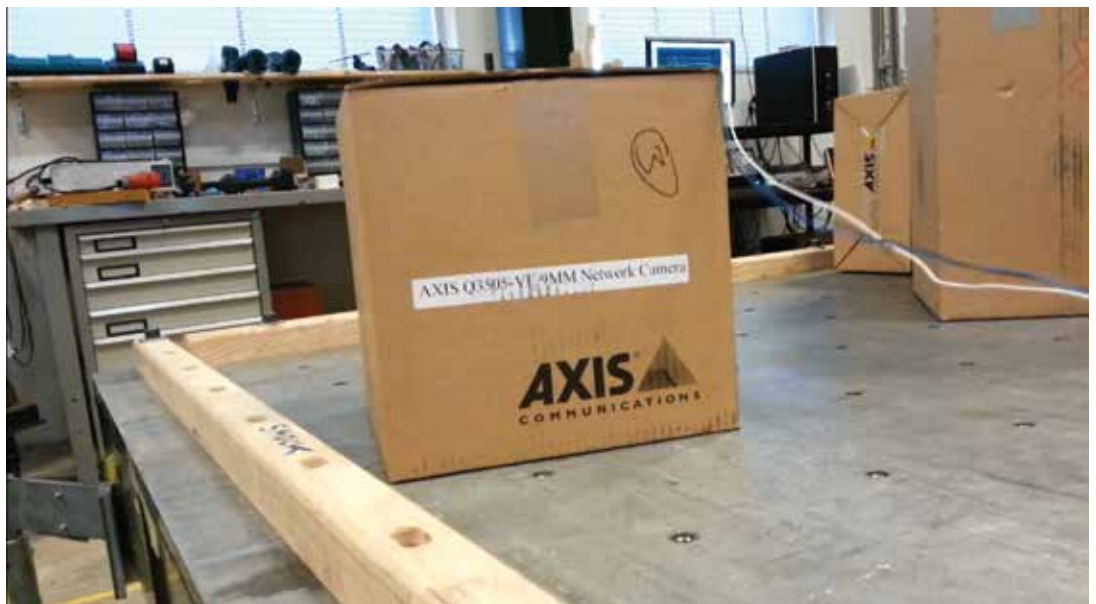
*Figure 4: Equipment used for the shipment test.*

Shipment tests are run on packages to determine the integrity of the packaging and its ability to protect the product. A camera, in its packaging, is placed on a platform. It is then subjected to a random vibration profile that replicates a bouncing truck on a poor-quality road. A typical test simulates thousands of miles travelled by road and air.

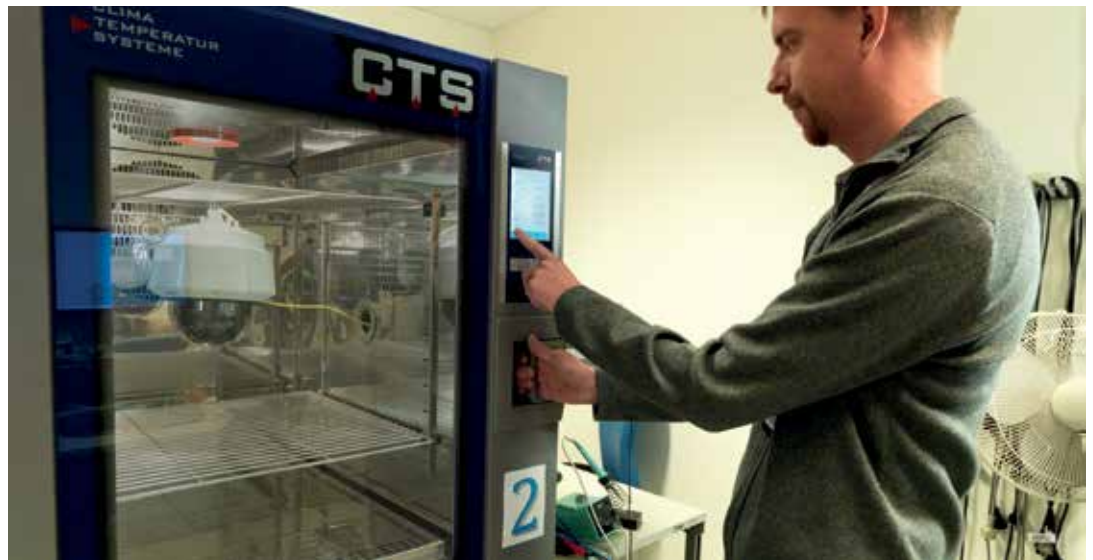
Figure 5: Temperature test in a climate chamber.

Temperature tests in labs are performed in climate chambers, where all types of temperatures and climates can be simulated. Tests are made with an interval margin of  $\pm 15$  °C ( $\pm 27$  °F) at either end of the operational temperature range. The humidity range spans from 0 to 100%.

Components as well as complete products are tested. All components have a margin of at least 5 °C (9 °F) to product specifications. Image quality tests are made in different temperatures to ensure image quality across the entire operating temperature range. In addition, condensation performance tests are made to ensure that fog does not build up in front of the lens inside the dome in high humidity environments.

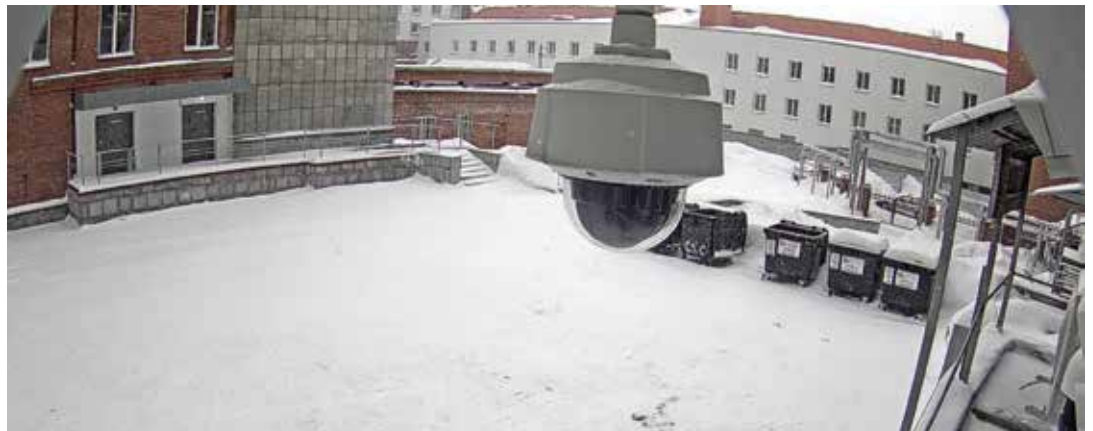
Figure 6: Axis test camera installed on site in Novosibirsk.

In addition to extensive lab tests, Axis products undergo live site tests for observation of long-term effects in real environments. The results give reliable data about condensation, corrosion, and mechanical and cosmetic defects of the tested products. Climate data, from a weather station mounted next to the products, is saved and analyses are conducted on all environmental parameters that the products are subjected to. The cameras are monitored round-the-clock for more than five years (44,000 hours).

Live site tests are performed in varying locations and climate zones all over the world: Lund in Sweden, Novosibirsk in Russian Federation, and Dubai in United Arab Emirates. The table below indicates the temperature and humidity ranges for the test locations, both during summer and winter.

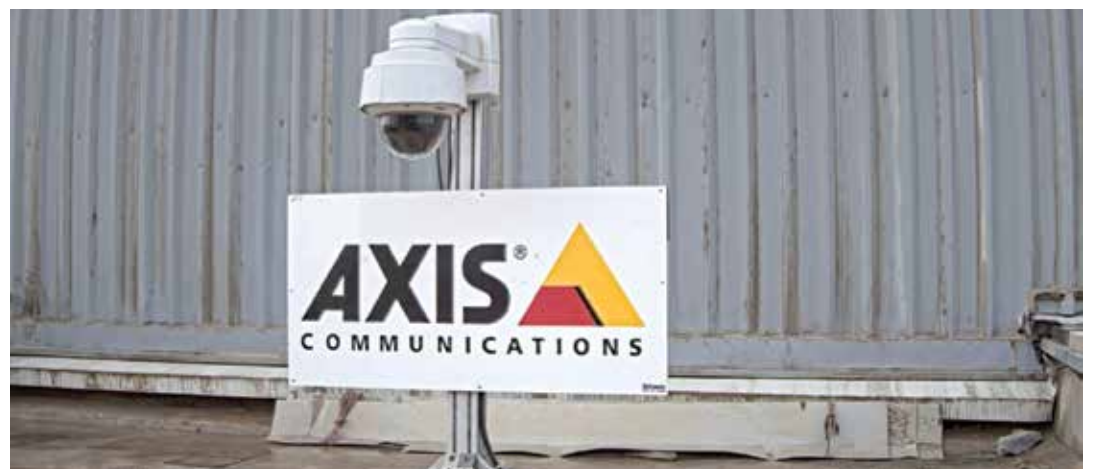
Figure 7: Axis test camera installed on site in Dubai.
